Amber Engineering Brno, a.s.

2002

DESCRIPTION:

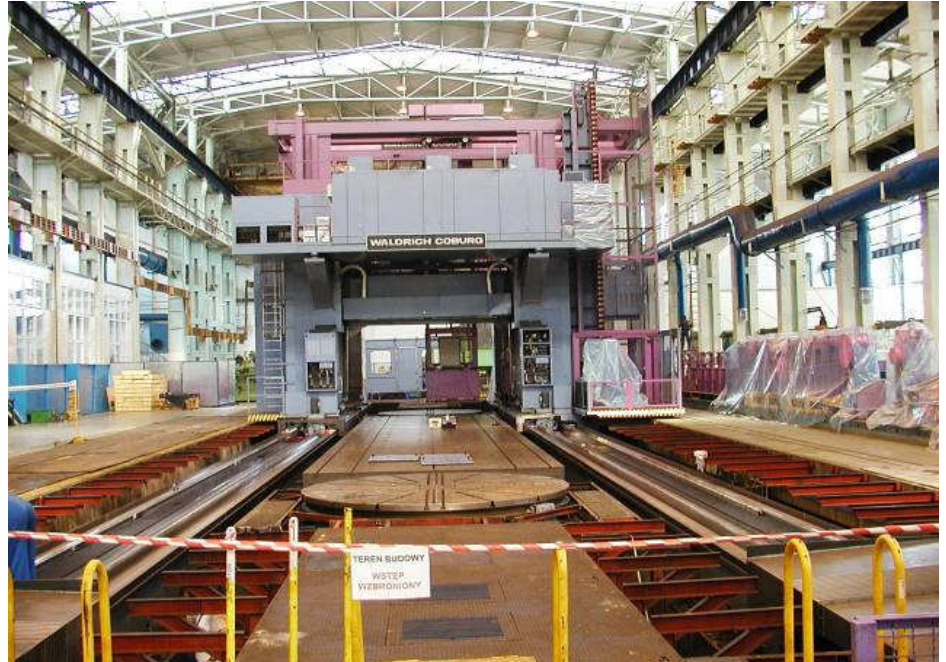
General view of double gantry cutter

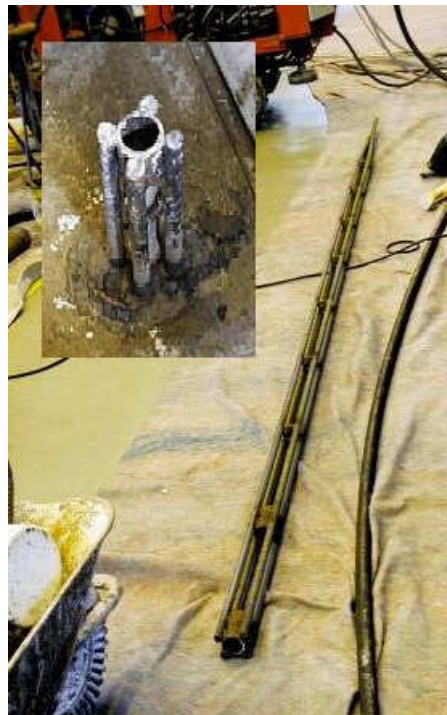
Reinforcement

Technical solution. The design office, together with Soletanche Czech Republic, proposed foundation reinforcement by jet grouting columns. In total the project planned 85 columns of 1000mm diameter, 12m long, through the mat. In order to improve rigidity of the whole, each column was equipped with a 12m long reinforcing cage, including 7m in the floor. We previously checked the technical solu-

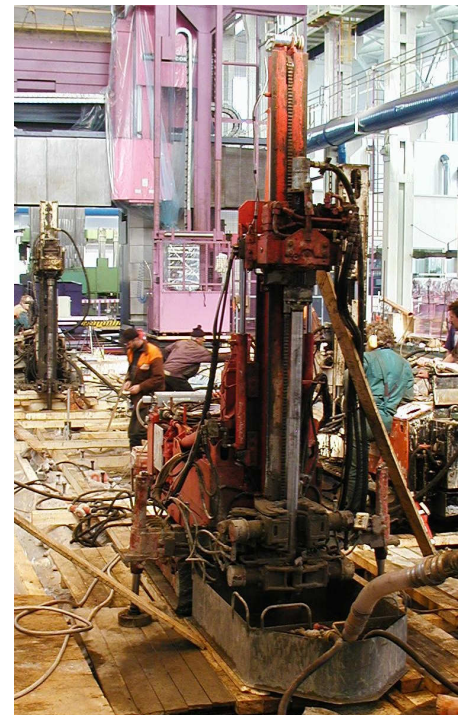
Jet-grouting works

Drilling and jet grouting operation. Working conditions were similar to those of an operating theater in a state-of-the-art hospital. During drilling, no vibration, shake, shock and dust were authorized. DTH hammer was thus proscribed. Of course, it was impossible to remove the cutter because three shift production was going on and could not be affected. This is why we did some drillings very close to the extremely fragile electronics and elements of this "mechanical jewel". All our operations were permanently closely controlled by the client's "audit army". The slightest error resulting in cutter deterioration or production slow down would have entailed the supervisor's "public execution" !

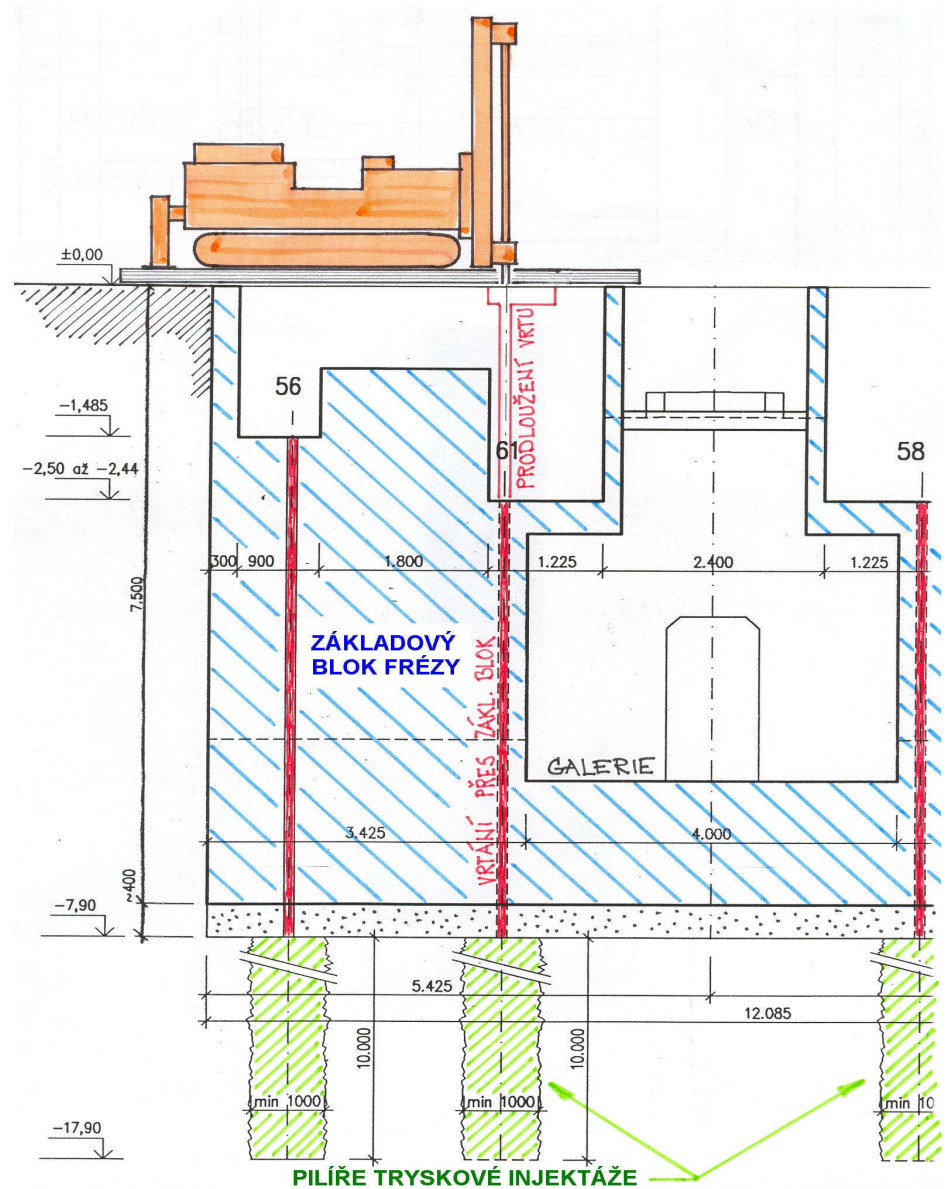
Inventory. The floor (12 x 43 x 7m) was in poor state : bad quality concrete, many cracks filled with machining emulsions, watertightness damaged by water seeping from technical galleries. Elblag is located on the Vistula River delta, on the Baltic seaside, which determines the site geology. Under a 5m thick impervious clay and peat layer, there is fine sand (2 to 5m thick) over hard layers. Since the natural ground is located 1,5m above sea and river level, the mat foundation is laying in saturated fine sands very prone to liquefaction.

Principle of underpinning
